USAAVLABS TECHNICAL REPORT 68-65

ADVANCEMENT OF HIGH-TEMPERATURE TURBINE TECHNOLOGY FOR SMALL GAS TURBINE ENGINES

FLUID-COOLED AXIAL FLOW TURBINE

Continental Report No. 1094

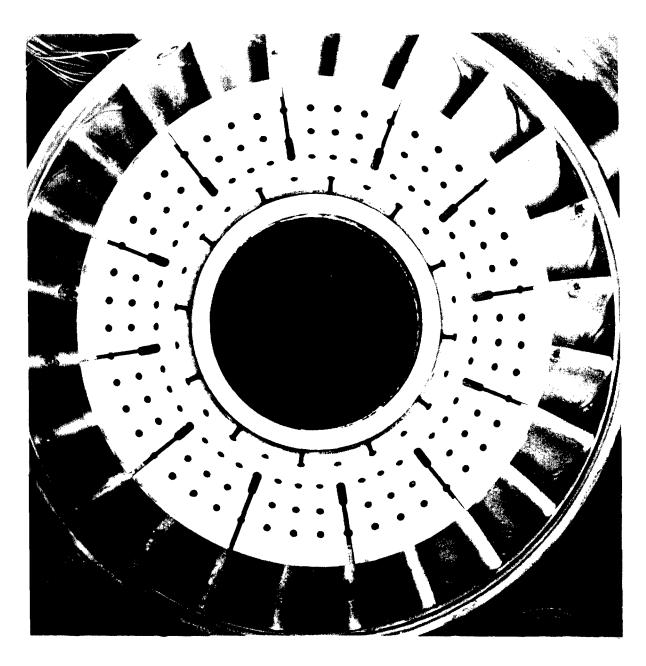
Figure 364. Modified Inner Combustor Shell.

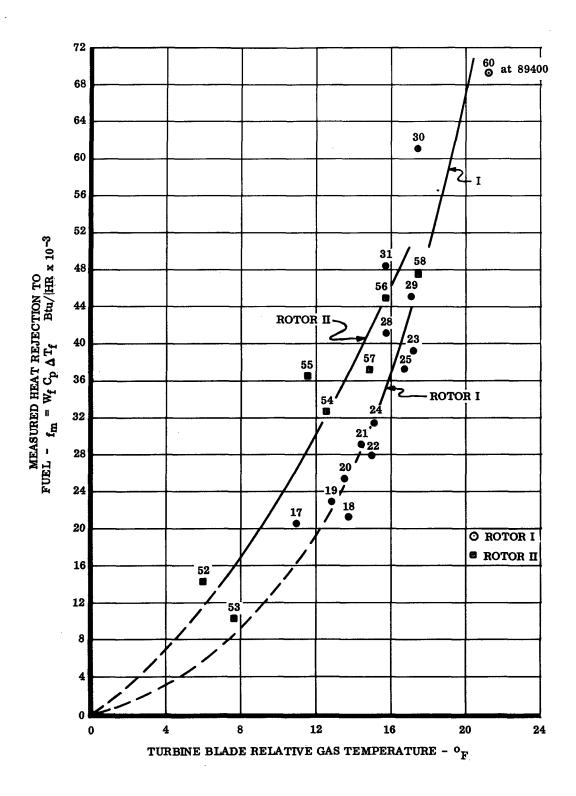
Figure 381. Heat Rejected to Fuel.

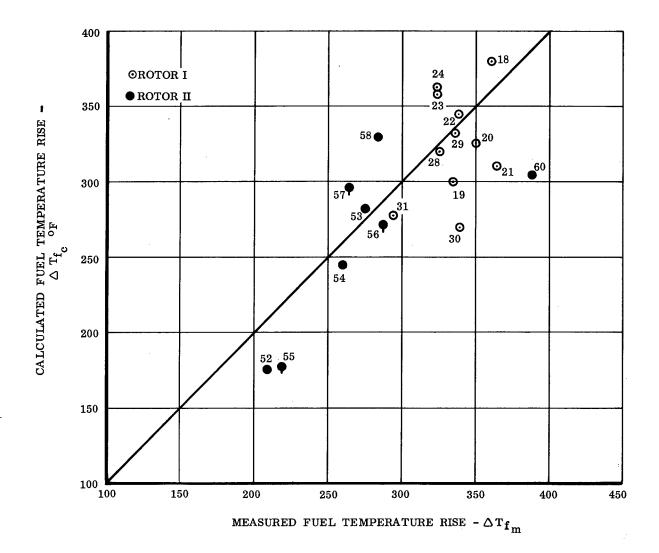
Figure 388. Comparison of Calculated and Measured Fuel Temperature Rise.

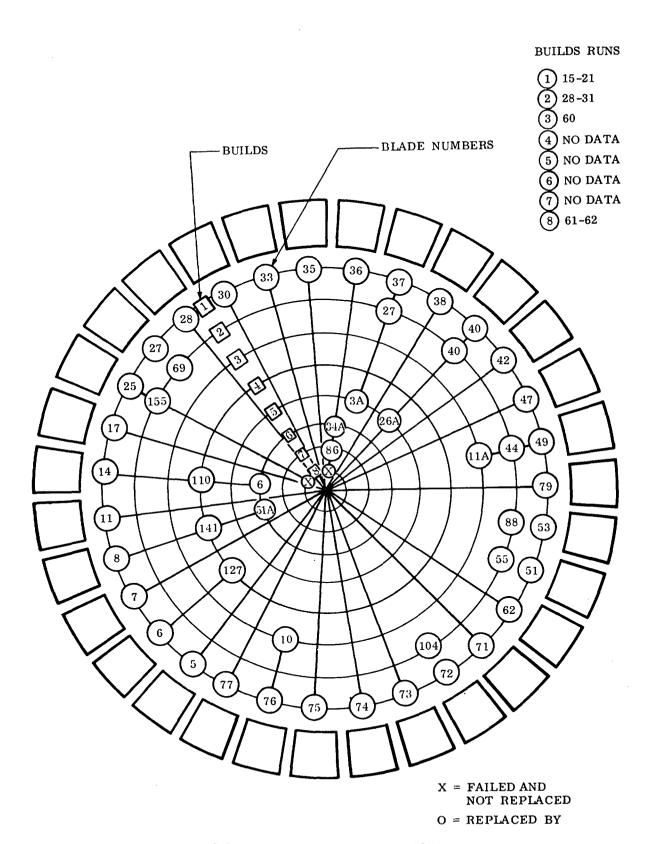
Figure 407. Turbine Rotor I Build History.

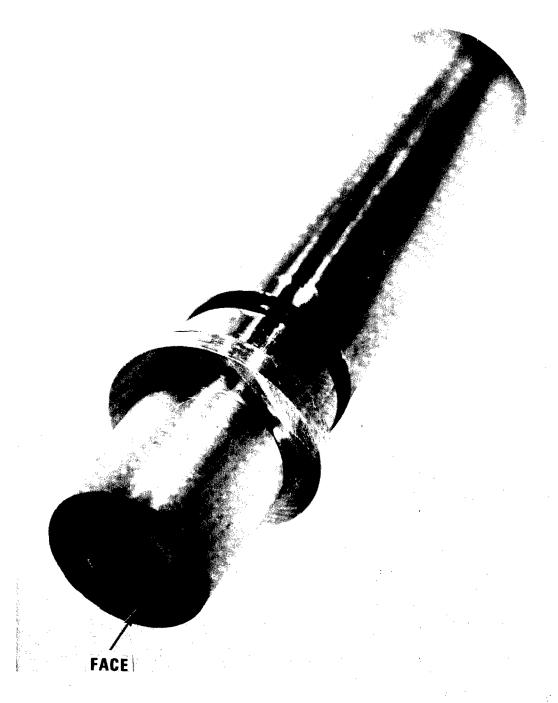
Figure 410. Fuel Wiper.

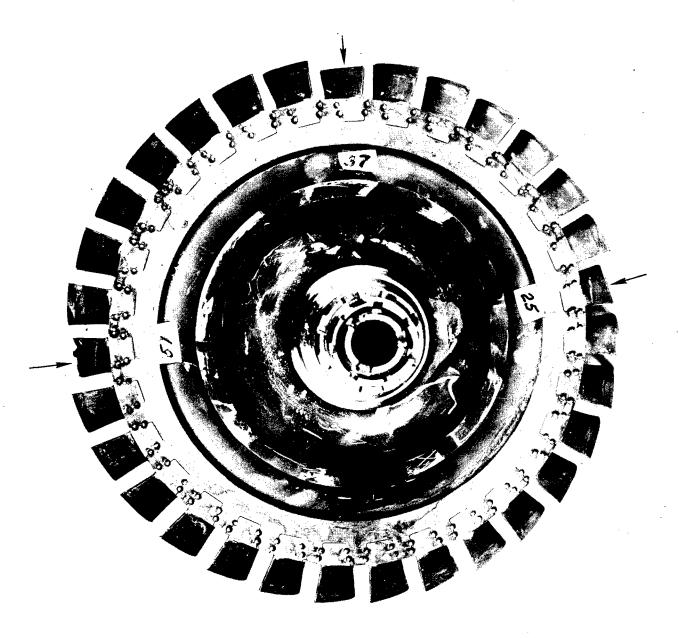
Figure 411. Turbine Rotor Tip-Cap Failures - Nos. 25, 37, and 51.

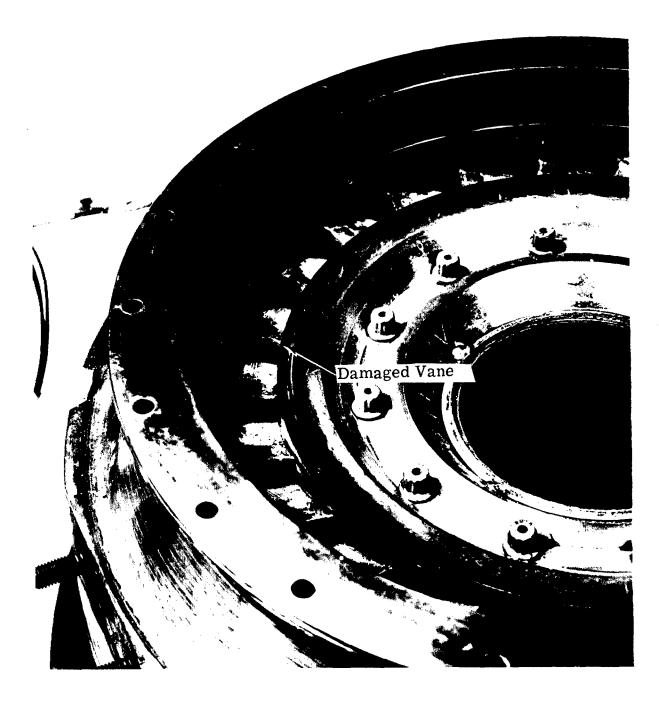
Figure 412. Nozzle Vane Assembly After Test 27 - Damaged Vane.

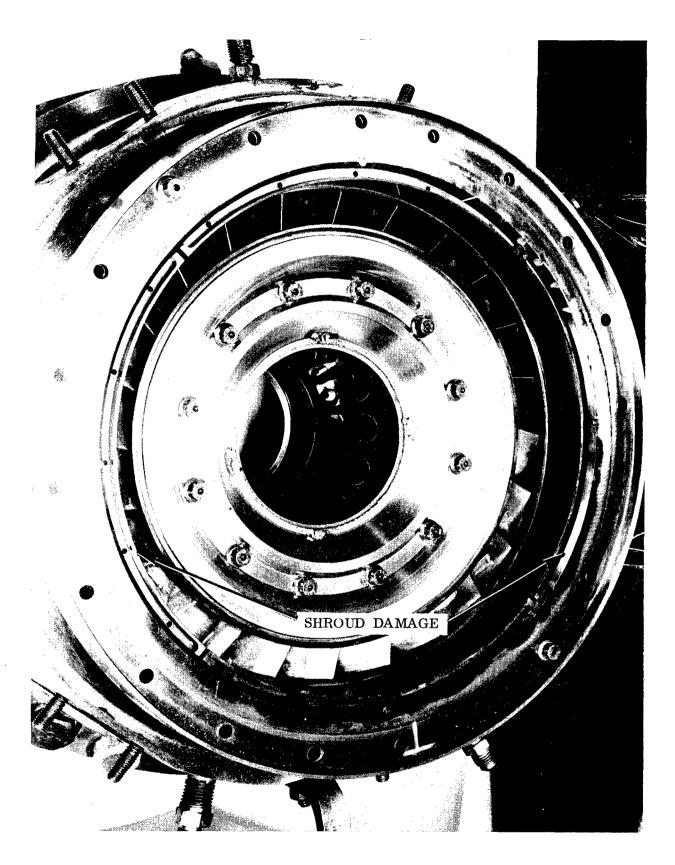
Figure 413. Turbine Shroud and Nozzle Vane Assembly.

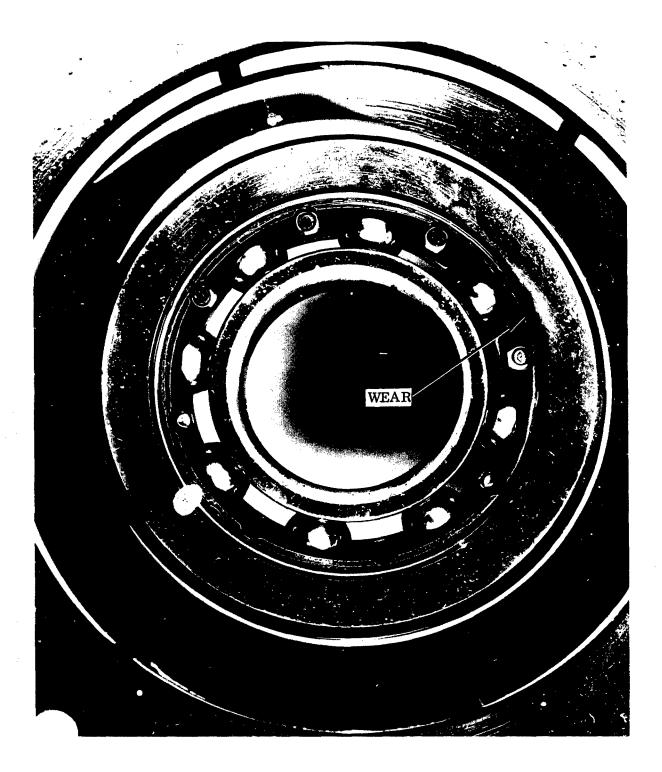
Figure 414. Forward Thrust Bearing.

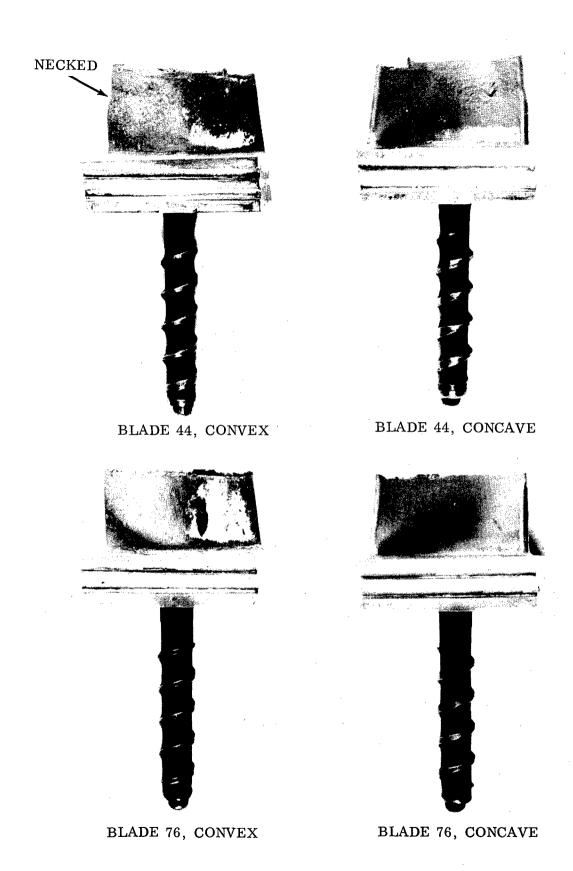
Figure 419. Blades 44 and 76 After Testing.

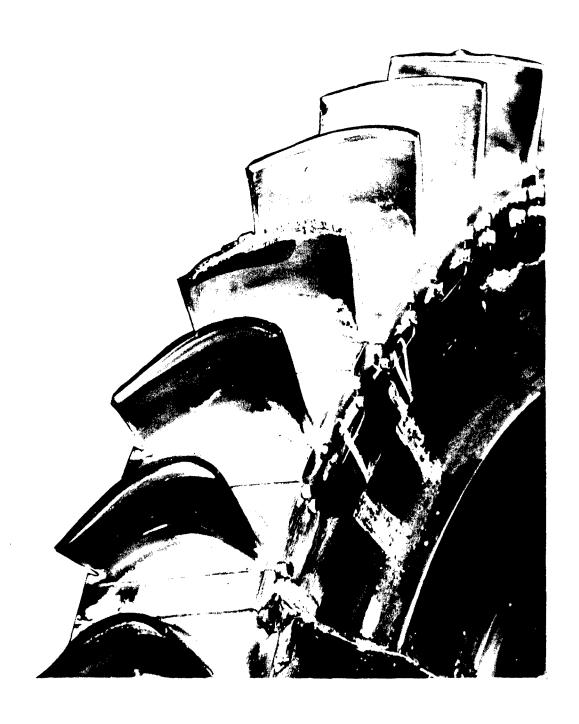
Figure 426. Turbine Rotor II - Tip-Cap Failure.

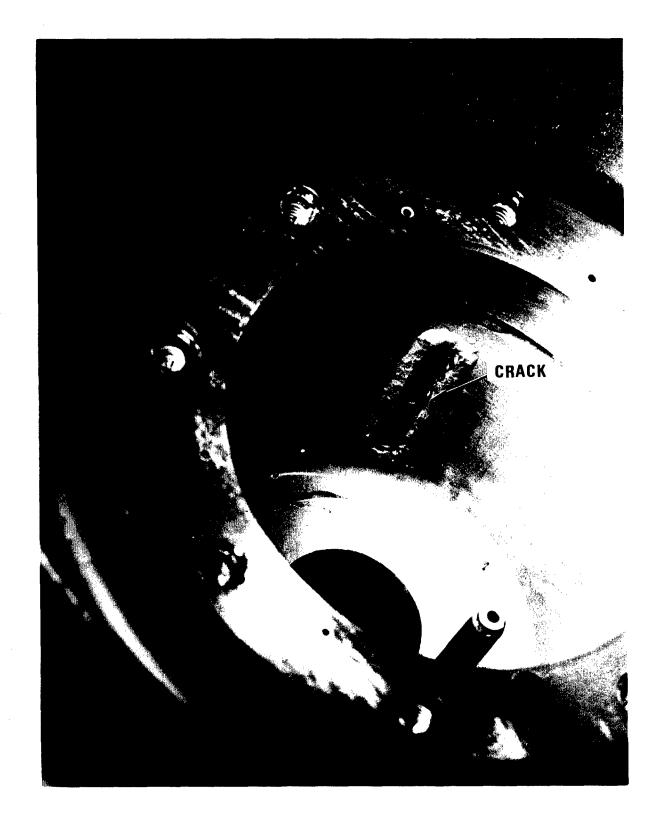
Figure 434. Exhaust Duct Oil Scavenging Port.

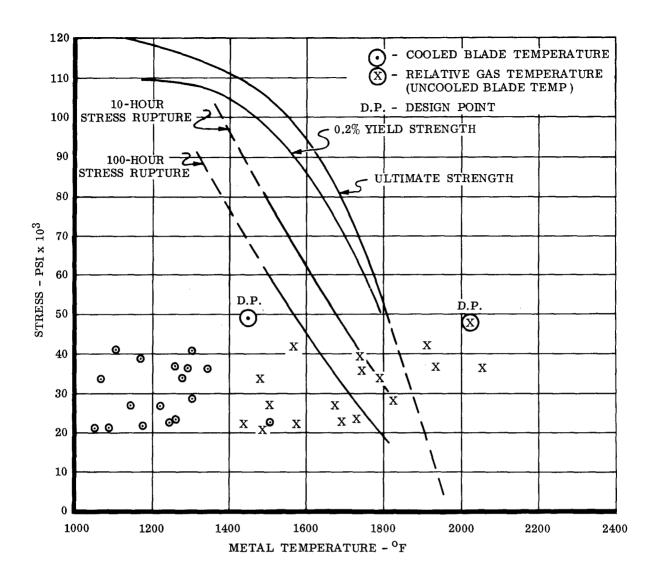
Figure 444. Stress-Temperature Relationship of Udimet 700.

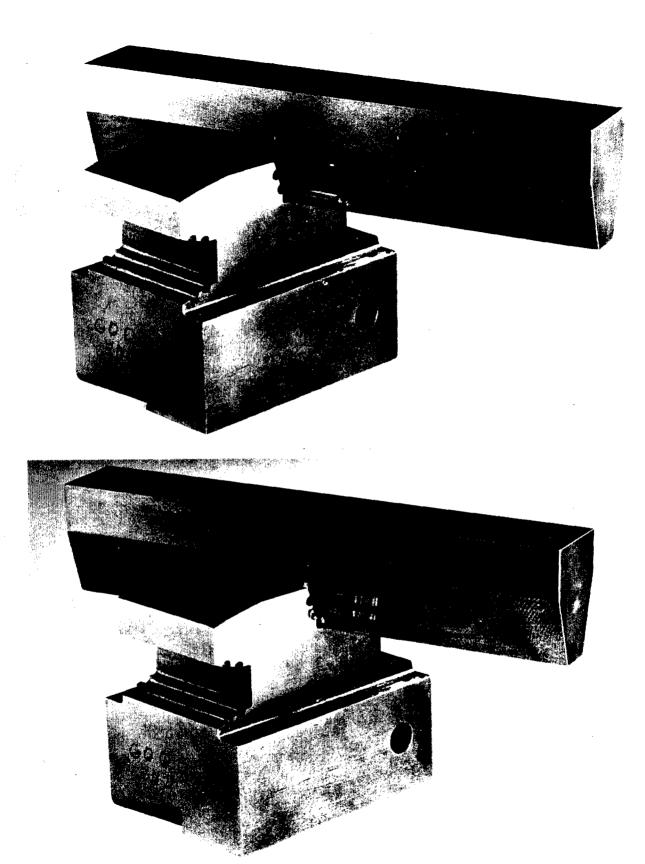
Figure 452. Rotor Pinhole Blade Attachment Sample, Fluid-Cooled Turbine.

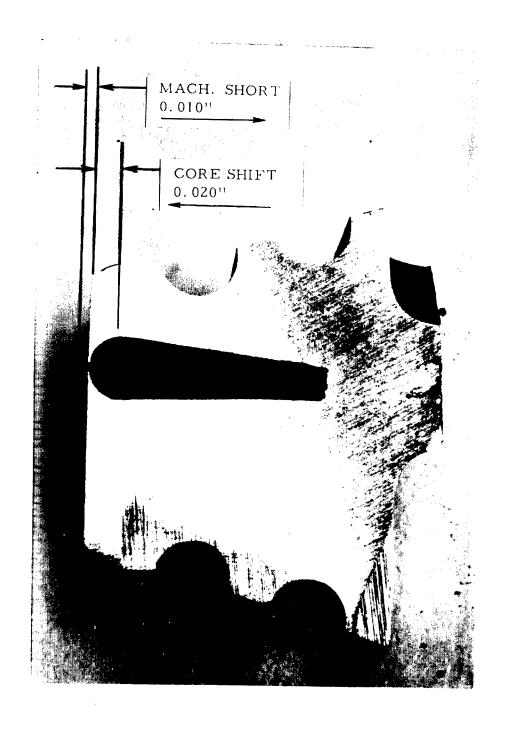
Figure 465. Turbine Blade Platform.

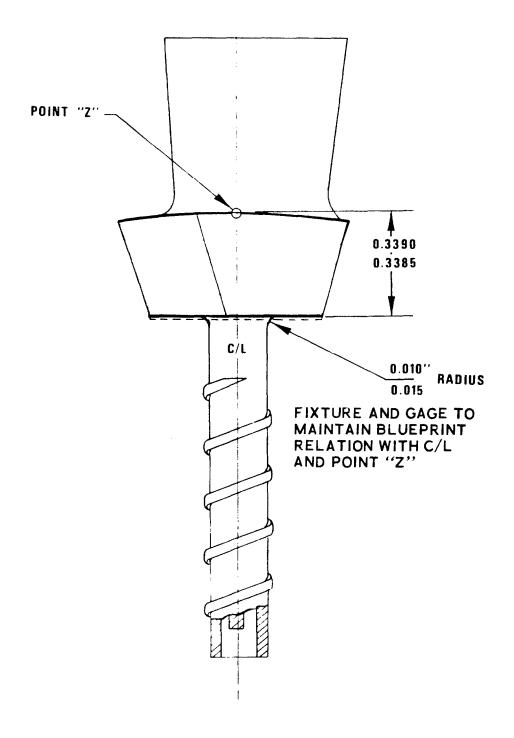
Figure 487. Heat Exchanger Machining Operation 20.
